# PRELIMINARY SITE INVESTIGATION REPORT

## **Robinson Creek Bridge Replacement on Lambert Lane Booneville, Mendocino County, California**

Existing Bridge 10C-0146  
BRLO-5910 (099)

January 15, 2021  
Project No. 16-278.1

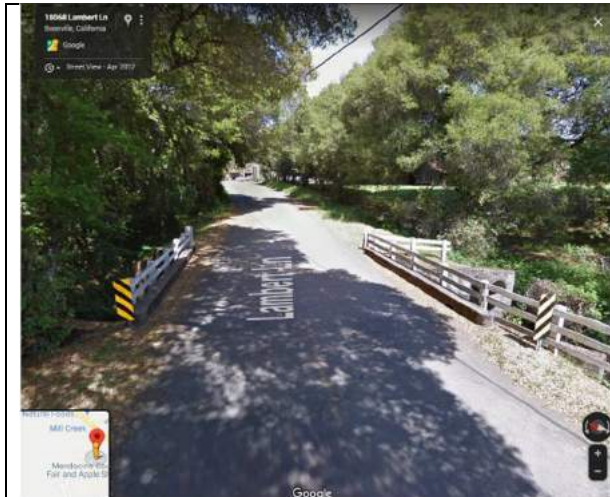
| Photograph#: | 1 | Robinson Creek Bridge |

Once at the physical bridge site, Ms. Johanson performed an entire bridge walk around and under, to visually assess the bridge structure. The bridge system is an asphalt/road base covered concrete deck system, with a concrete abutment and wood railing. Since the bridge is failing, the County has installed a temporary green steel span over the old bridge.
